# Lower Baker Dam Leakage Investigations

**Jim Sammet, PE**  
**Lower Baker Dam Capital Program Manager**

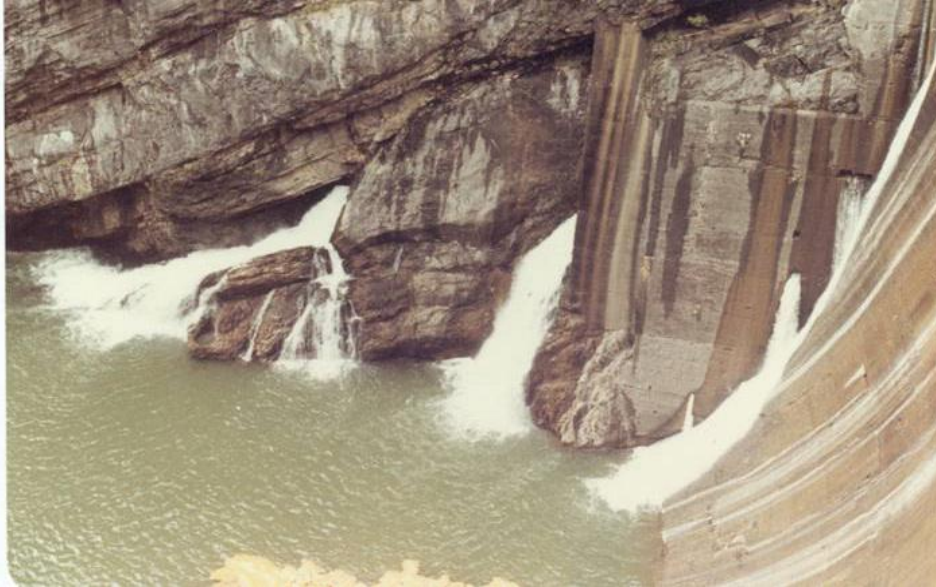
Right Abutment  
1982 – 140cfs

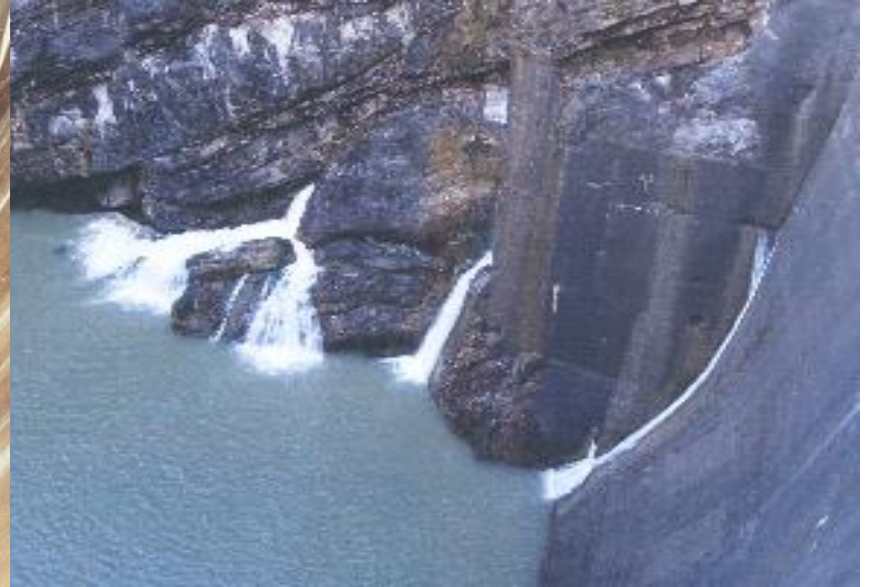
Right Abutment  
2012 - 132 cfs

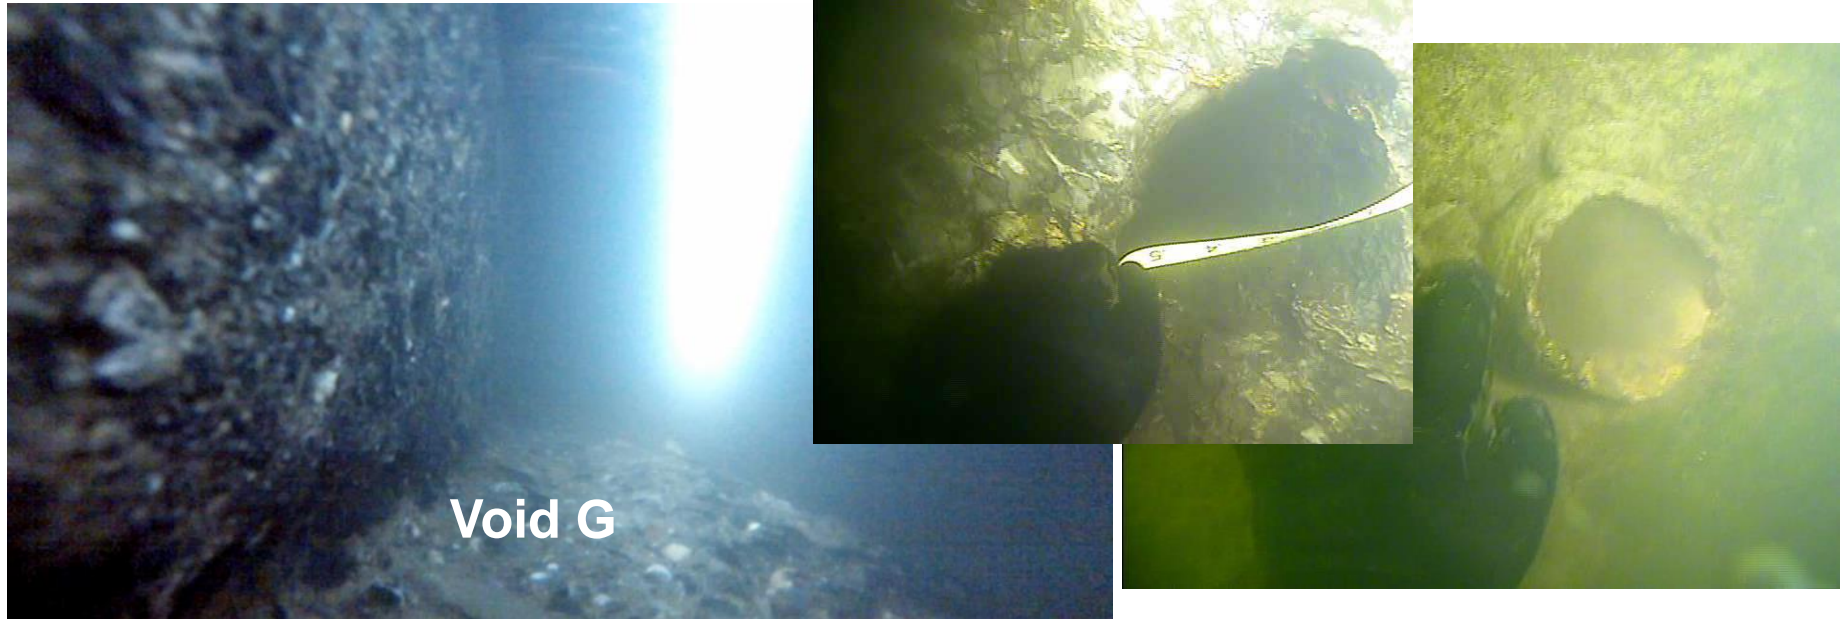
- Toe dive in 2010 showed high velocity flow from Void G located near the east end of the Apron.
- Observations prompted additional leakage investigations to better understand leakage and drainage characteristics of the dam site.

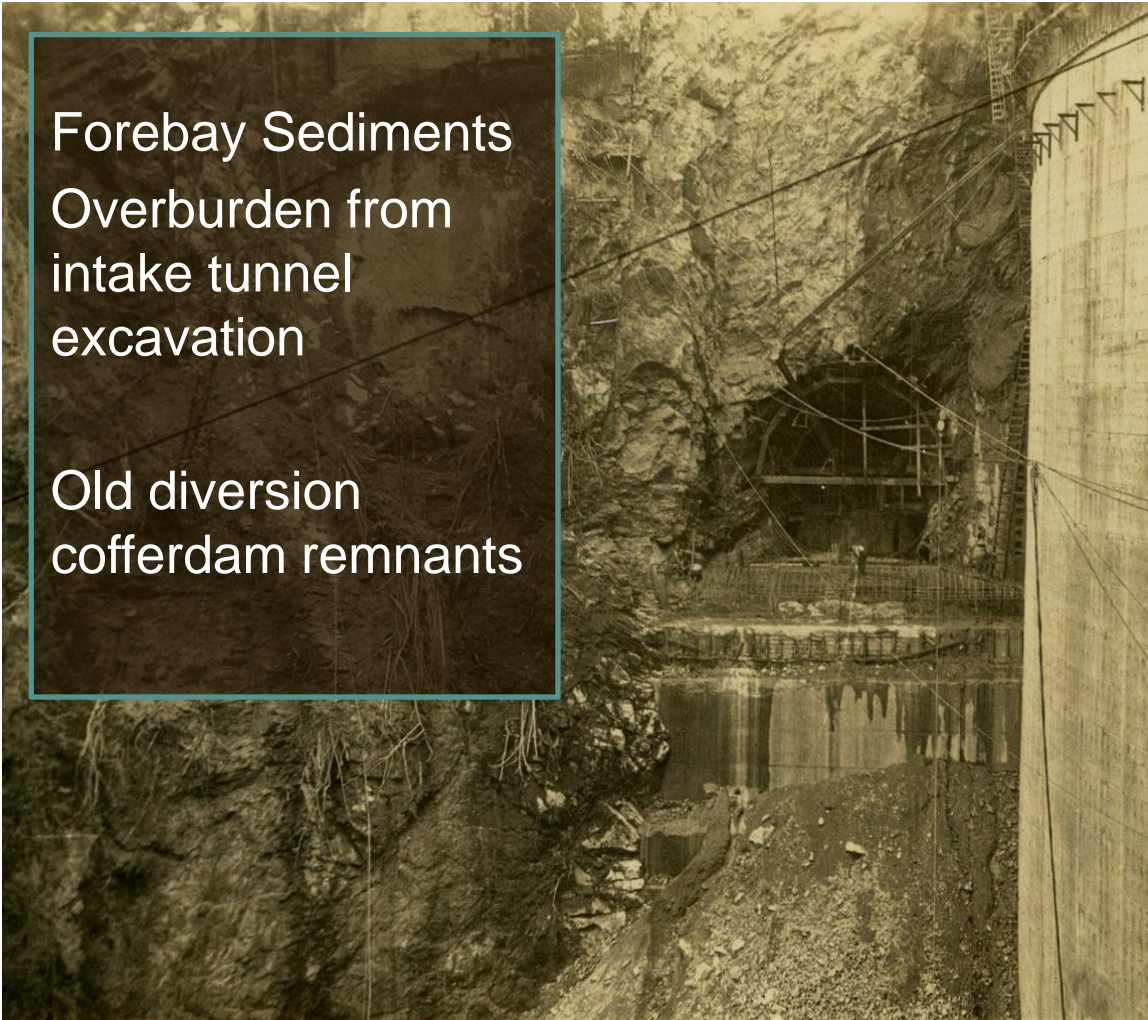
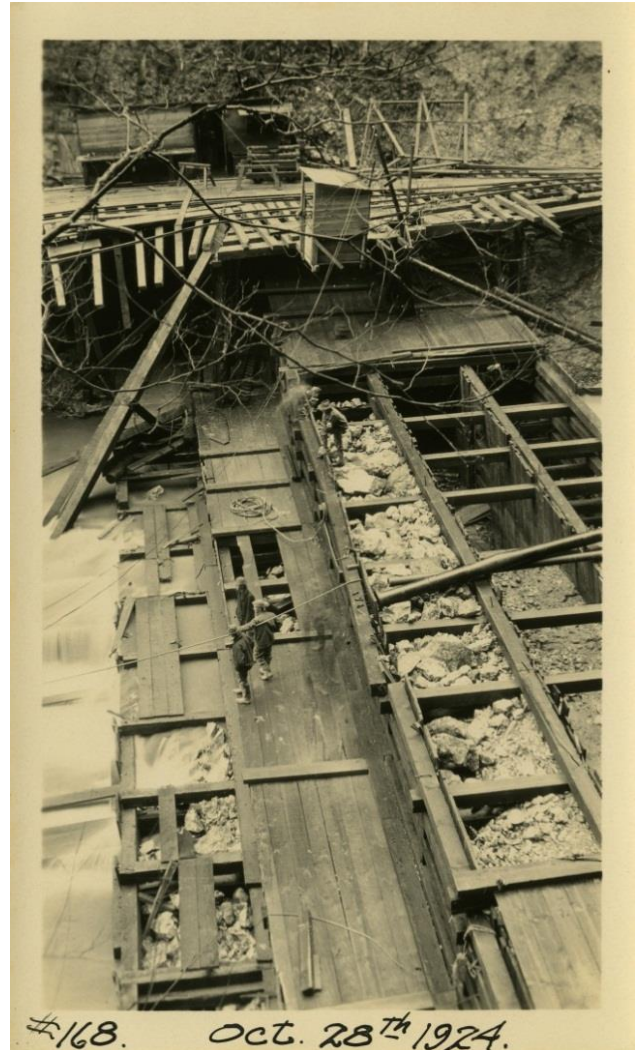
Forebay Sediments  
Overburden from  
intake tunnel  
excavation

Old diversion  
cofferdam remnants

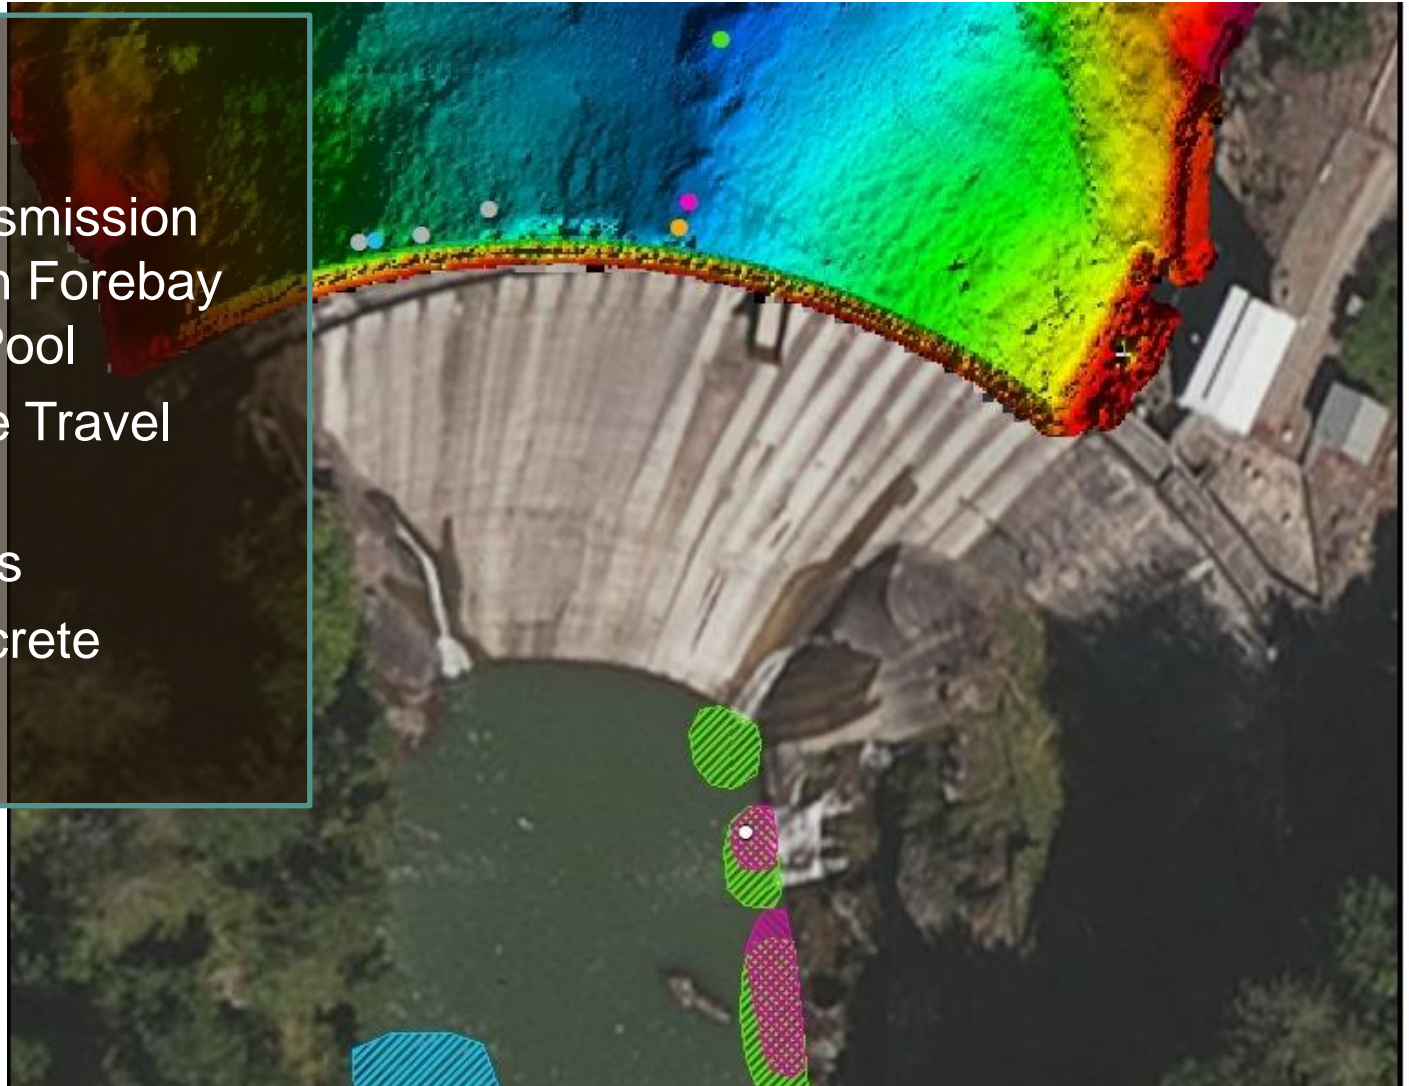
- Rapid Transmission Times From Forebay to Plunge Pool
- 3-10 Minute Travel Time
- 0.4 – 1.4 fps
- Shows Discrete Pathways

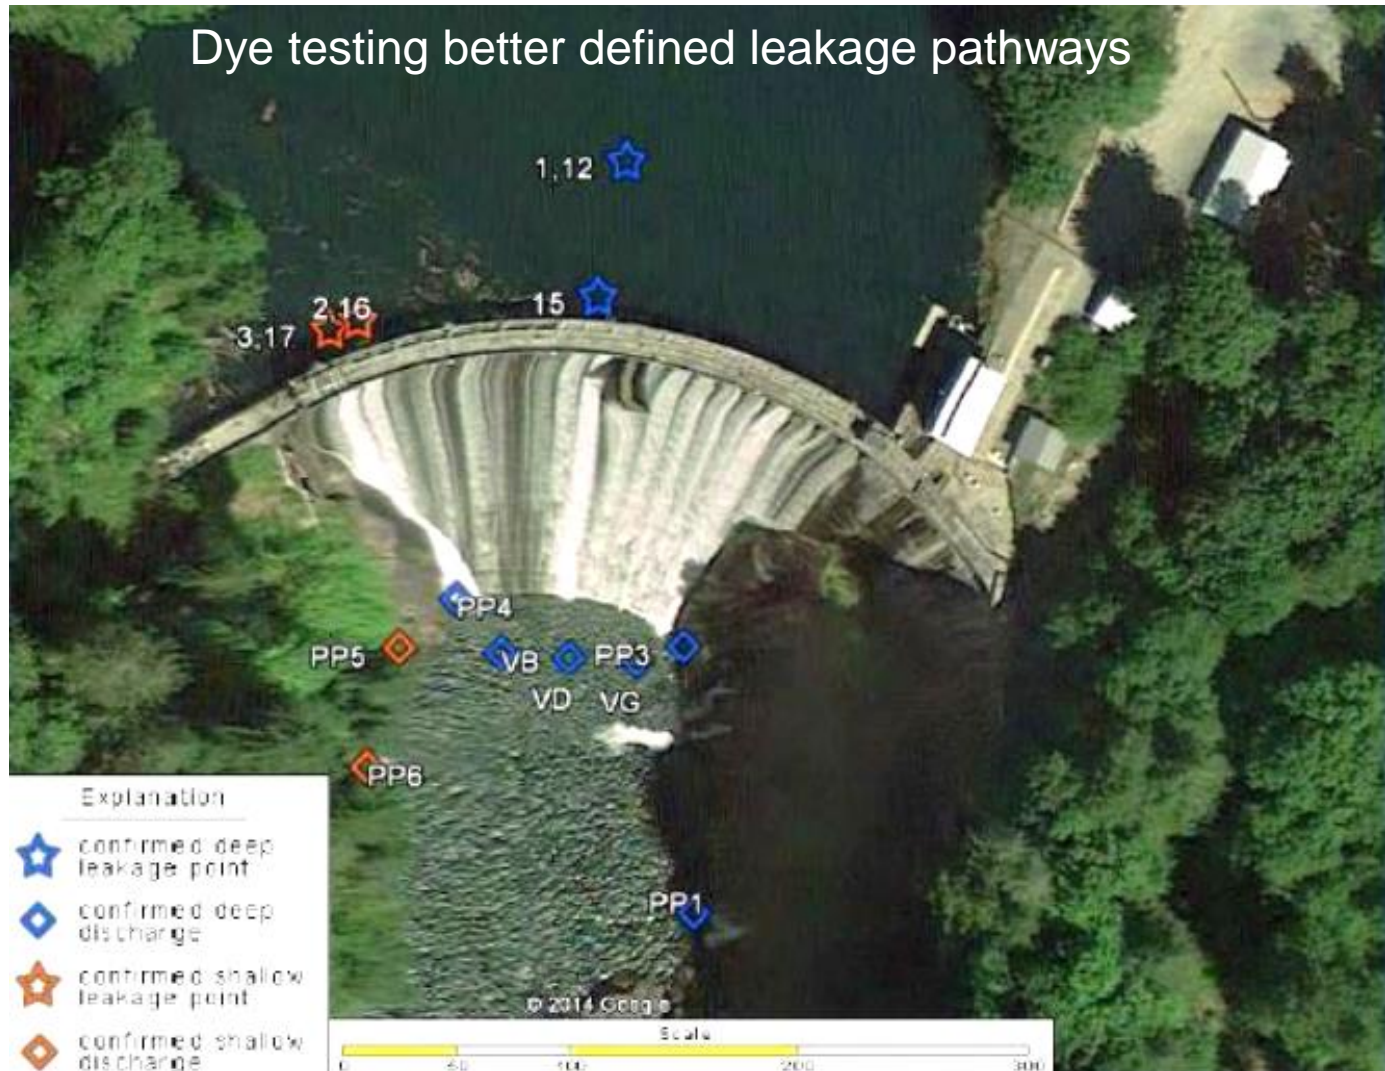
Dye testing better defined leakage pathways

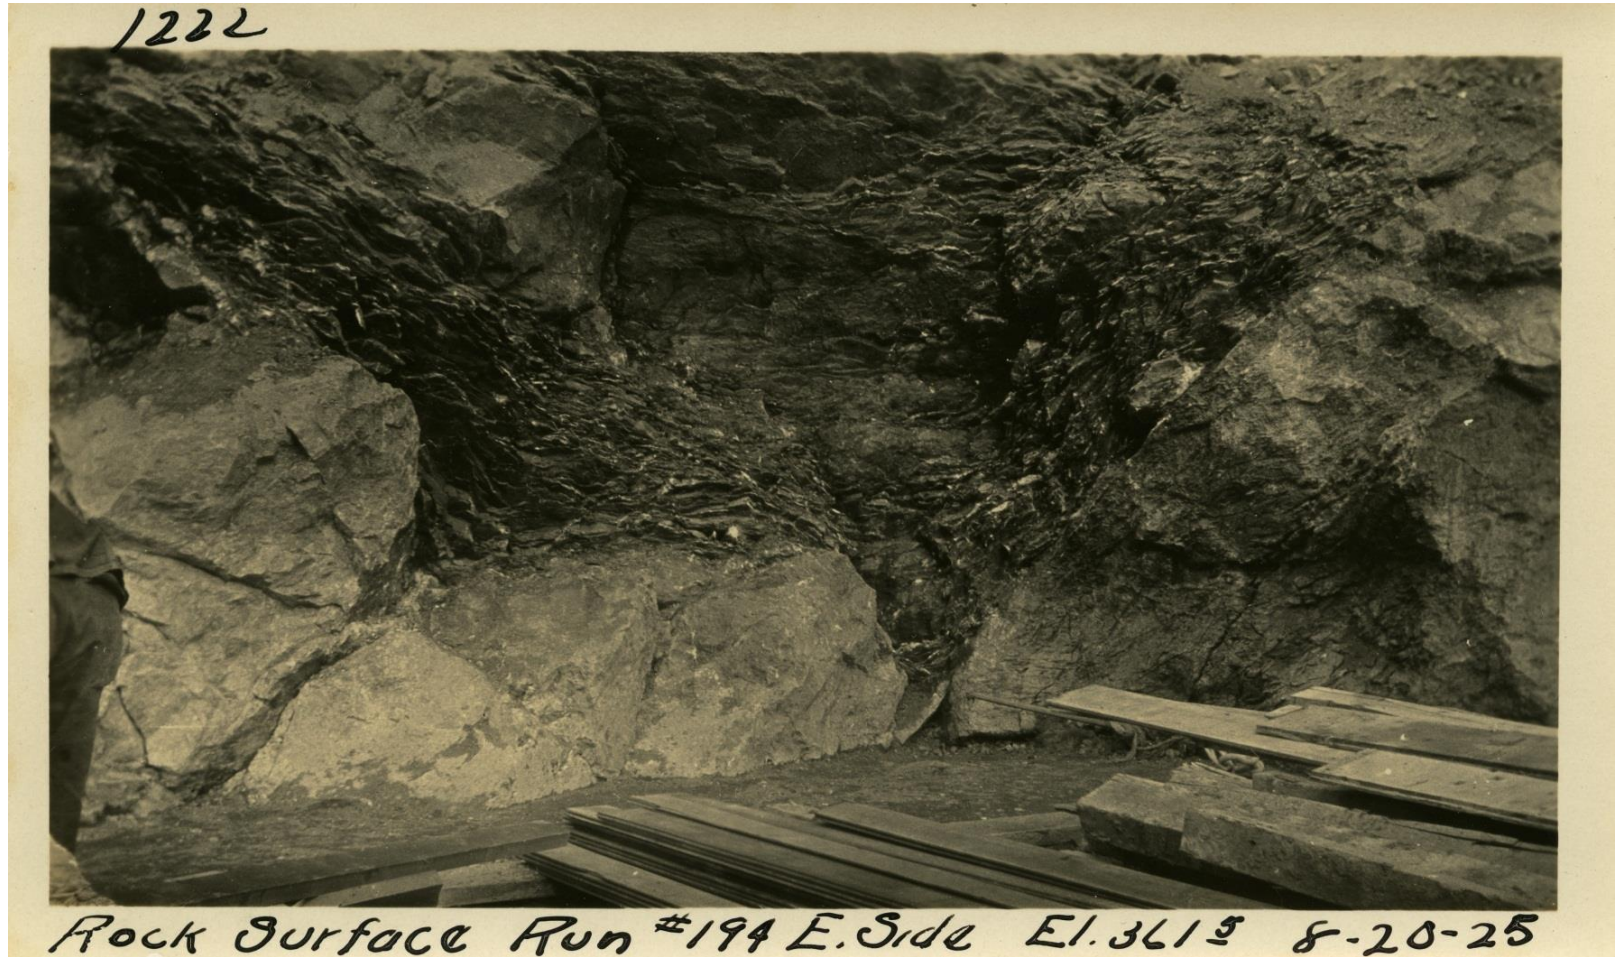
Shale seem in limestone abutments
